FAILURES OF SEWER PIPES MADE OF PVC / УШКОДЖЕННЯ КАНАЛІЗАЦІЙНИХ КАНАЛІВ ВИКОНАНИХ З ПВХ ТРУБ

This paper presents the field measurements results of sewer pipes made of PVC, which were newly laid in the ground. The research was carried out applying CCTV (Closed Circuit Television) inspections, which was performed during the construction works acceptance of the sewer pipes some weeks or months after their laying in the ground. More than 11 km of sewers from 11 cities in Poland were analyzed. The analysis was carried out based on the research conducted among other things by Kielce University of Technology. A detailed analysis of specific flexible pipes failures was carried out. Failures, which occurred most frequently and on the highest percentage of the sewer pipe lengths were identified. The failures were classified according to the intensity of their occurrence and caused danger. Class 1 covers the greatest failures and the highest level of danger, class 5 covers minor failures with the lower level of danger. The technical condition of the investigated sewers was assessed by classifying the particular sections to one of 3 groups: G 1 – without failures, G 2 – with failures in 5th c

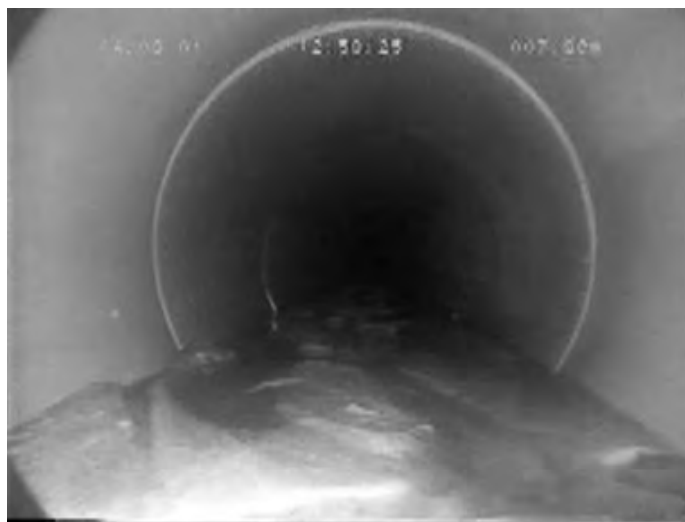
The sediments in the bottom of the sewer, which come from the construction period, were connected in most cases with improper longitudinal gradient of the sewers. More than 80% of those sediments were assigned to 5th class of failures, because they occupied less than 5% of the sewer cross-section. To 4th class there was classified 15.17% of the sewer length which were occupied by the sediments, to 3rd class 1.74%, to 2nd class 0.39%, to 1st class only 0.04% of the sewer length which was occupied by the movable sediment occupying more than 50% of the sewer cross-section. Figure 10 shows the movable sediment, which was classified to 4th class of failures.

Fig. 10. The movable sediment, which was classified to 4th class of failures

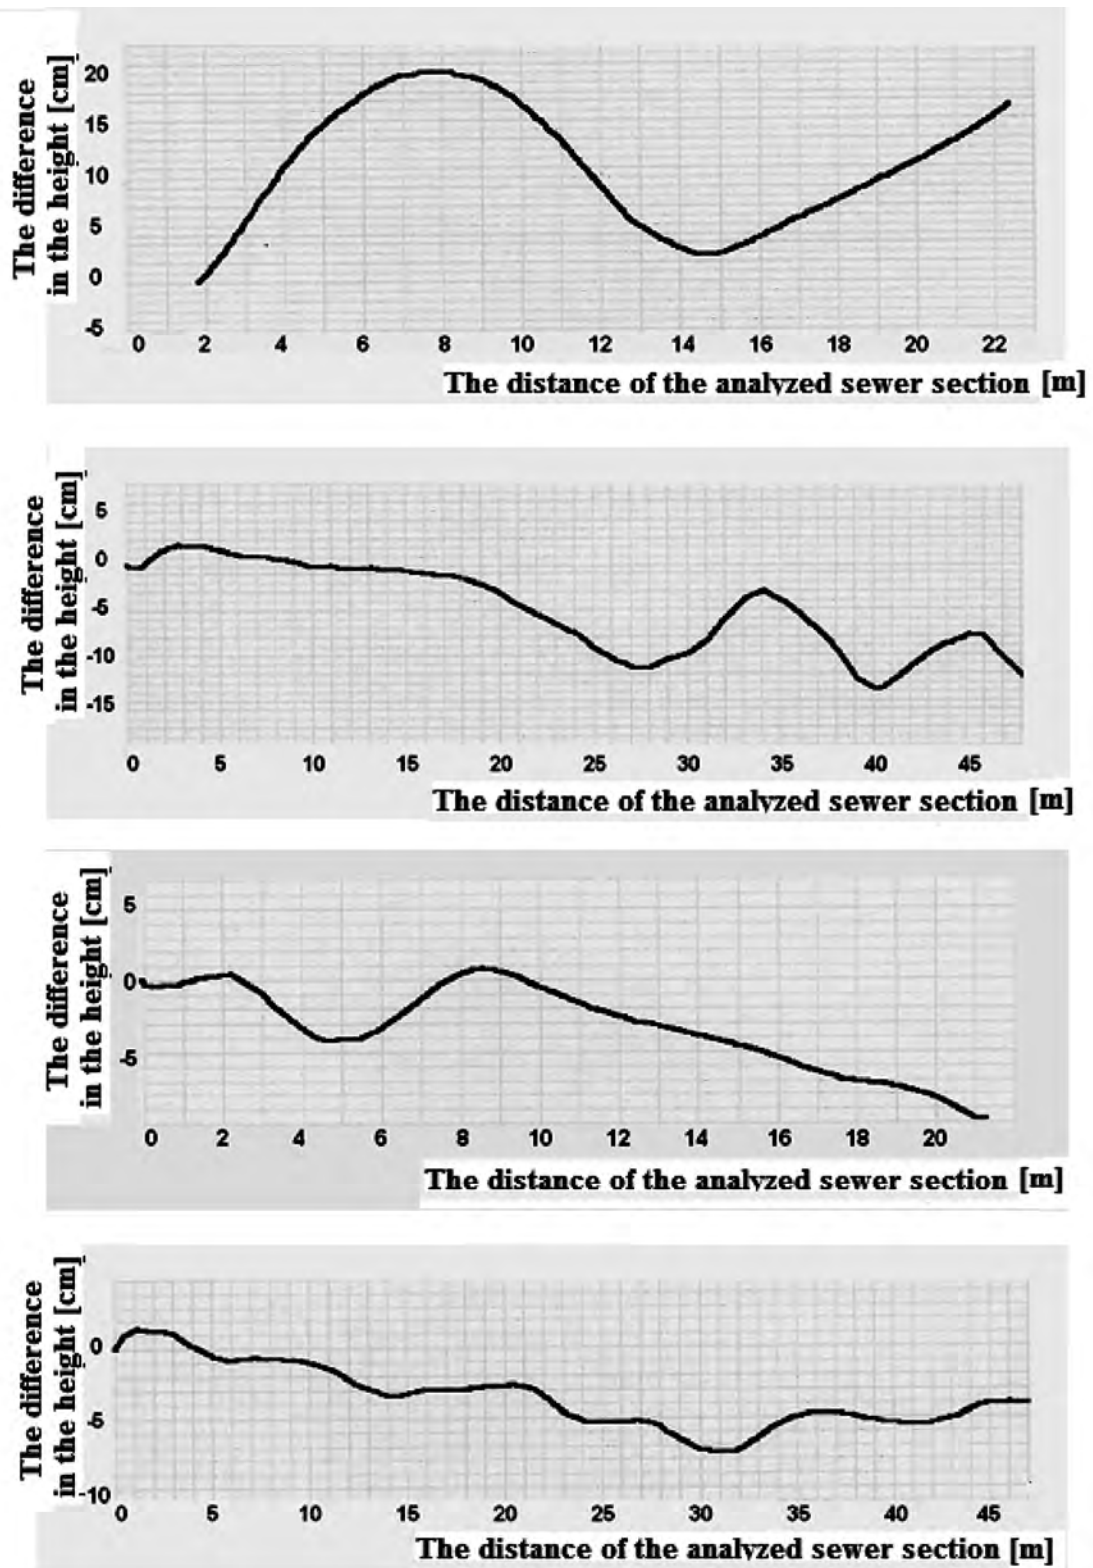
Figure 11 shows four examples of the improper sewer longitudinal gradients. On X- axis there was shown the distance of the analyzed sewer section in [m] measured from the manhole to manhole, on Y-axis the registered difference in the height of the sewer bottom between the particular point on the sewer section and the 1st manhole in [cm].

Fig. 11. Improper longitudinal gradients of the sewers

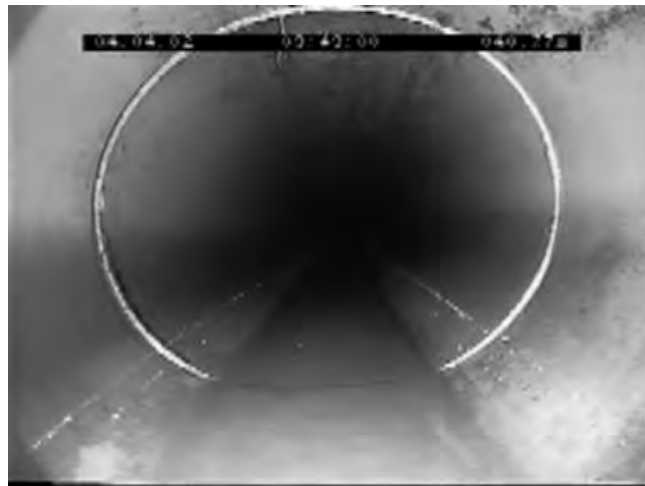
The deflection of the pipe's top was observed on the considerable pipe's length. In 86.6% they were minor deflections, lower than 6%, qualified to 5th class of failures. To 4th class of failures there were classified 13.3% of the deflected pipes, where deflections were more than 6% and less than 15%. According to the proposed classification only 0.1% of the deflected pipes were classified to 3rd class. Their deflection was more than 15%. The deflection of the top of the pipe classified to the 4th class was shown in figure 12.

Fig.12. The deflection of the top of the pipe in the 4th class of failures

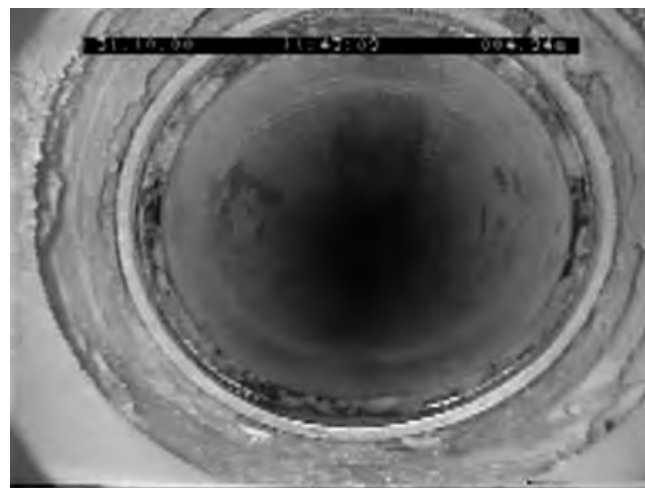
The point failures which were most commonly observed were: longitudinal displacements. The most of the longitudinal displacements (91.7%) was observed in the 5th class of failures. Only in one place (1st class – 0.3%) there was the direct contact of the interior of the pipe with the ground, shown in figure 13. Low one-sided longitudinal displacements (5th class) are shown in figure 14. It indicates the improper longitudinal slope.

Fig. 13. The longitudinal displacement in the 1st class of failures

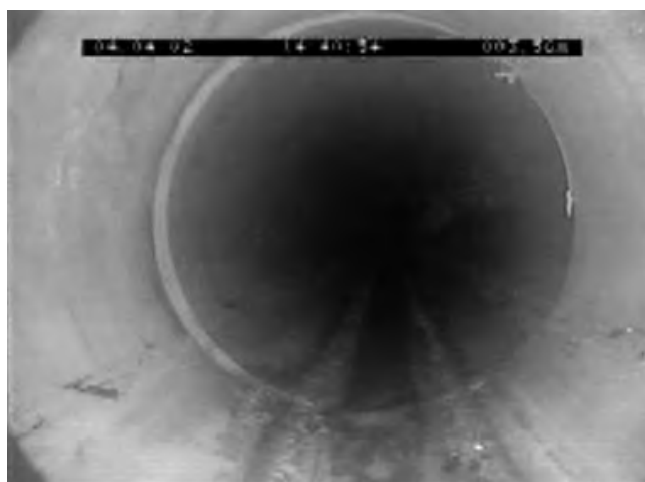
Fig. 14. One sided longitudinal displacement in the 5th class

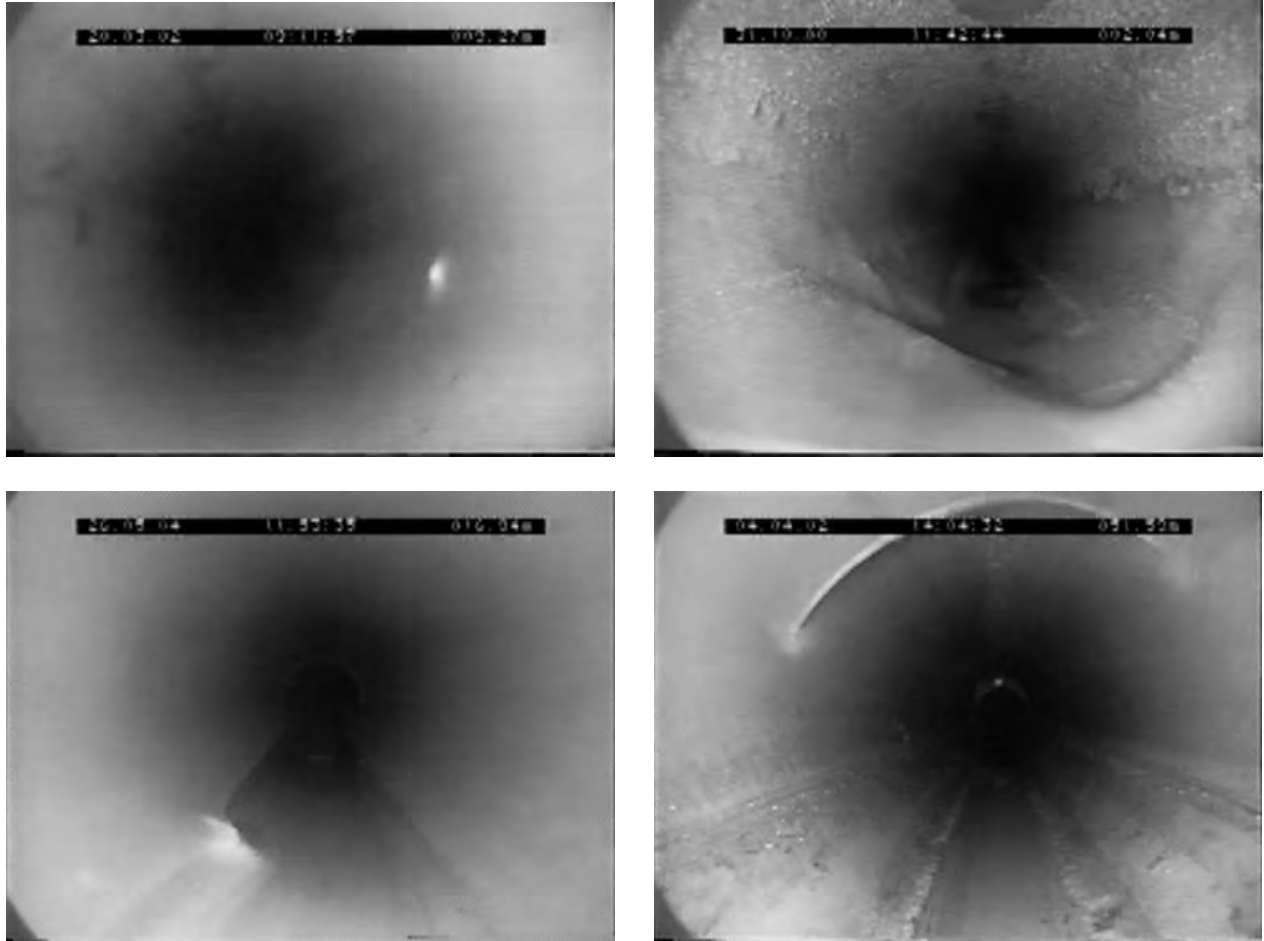
More than half of the observed local dents e.g. from the cobbles were classified to the 4th class of failures. Less of the failures (26.6%) were classified to the 3rd class, much less (16.4%) were classified to the 2nd class. One dent of 1.3% was classified to 1 st class and was larger than 20 mm. The examples of the local dents are shown in figure 15.

Fig. 15. The examples of the local dents of the pipe

The local dents observed in the investigated sewers indicate the careless carrying out the sand bedding and sand backfill of the pipes.

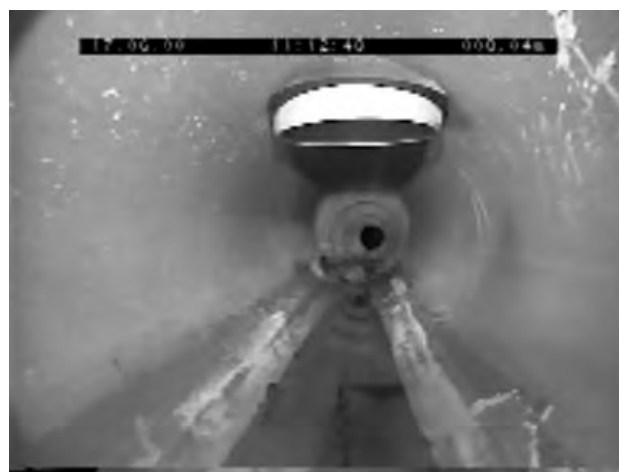
Fig. 16. The house sewer that juts out to the pipe interior

The house drains or the sealing that jut out to the interior in 55.6% occupied less than 5% of the pipe cross section and were classified to the 5th class of failures. 44% of those obstacles in the flow were classified to the 4th class, as they occupied more than 5% but less than 20% of the pipe interior. In figure 16 there is shown the house drain that juts out to the pipe's interior and unables the progress of the camera. In figure 17 there is shown the sealing which juts out of the connection.

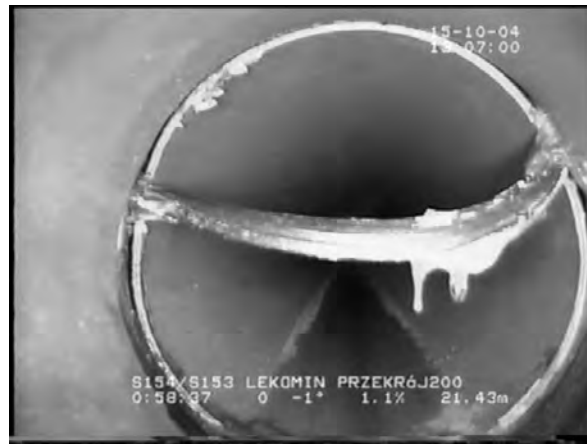
Fig. 17. The sealing that juts out from the place of pipe connection to the pipe interior
