FAILURES OF SEWER PIPES MADE OF PVC / УШКОДЖЕННЯ КАНАЛІЗАЦІЙНИХ КАНАЛІВ ВИКОНАНИХ З ПВХ ТРУБ

This paper presents the field measurements results of sewer pipes made of PVC, which were newly laid in the ground. The research was carried out applying CCTV (Closed Circuit Television) inspections, which was performed during the construction works acceptance of the sewer pipes some weeks or months after their laying in the ground. More than 11 km of sewers from 11 cities in Poland were analyzed. The analysis was carried out based on the research conducted among other things by Kielce University of Technology. A detailed analysis of specific flexible pipes failures was carried out. Failures, which occurred most frequently and on the highest percentage of the sewer pipe lengths were identified. The failures were classified according to the intensity of their occurrence and caused danger. Class 1 covers the greatest failures and the highest level of danger, class 5 covers minor failures with the lower level of danger. The technical condition of the investigated sewers was assessed by classifying the particular sections to one of 3 groups: G 1 – without failures, G 2 – with failures in 5th c

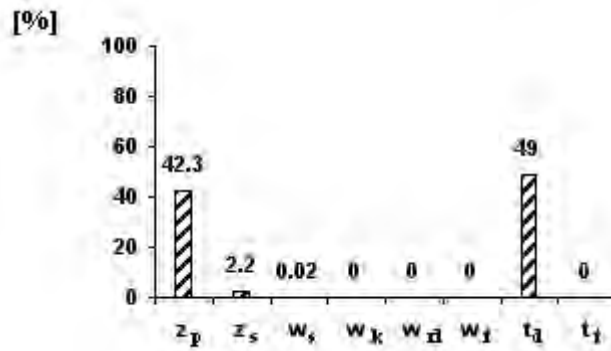
Fig. 1. The summary results of the investigation of various linear failures

As it is shown in figures, the linear failures, which occurred on the considerable length of the sewers are: the deflection of the top (49,0%), the movable sediment (42,3%) and immovable sediment (2,2%). The following figures present those failures divided into classes of intensity of their occurrence.

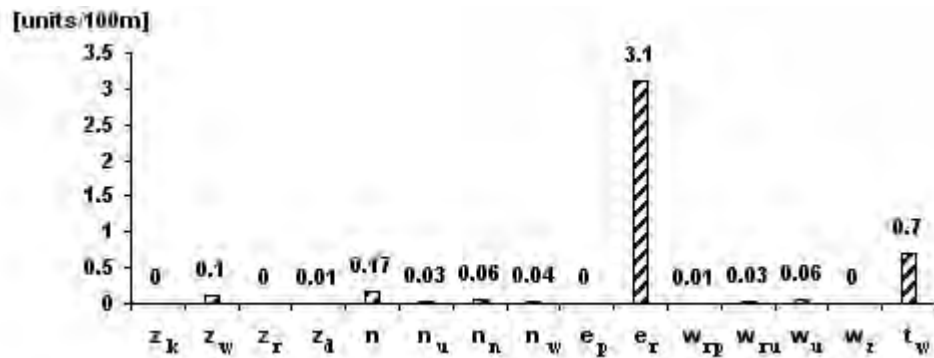
Fig. 2. The summary of the intensity of occurrence of the various point failures in units/100 m

The point failures, which occurred quite often were the longitudinal displacements, which were 3.1 piece/100m. The other failures were observed more rarely than 1 piece/100 m of the Sewer length. However, worth mentioning are: local dents 0.7 piece/100 m, infiltration 0.17 piece/100 m, Figure 6 presents the per cent share of the longitudinal displacements, which was signed by the e_r in five classes of failures. The division into classes is as follows:

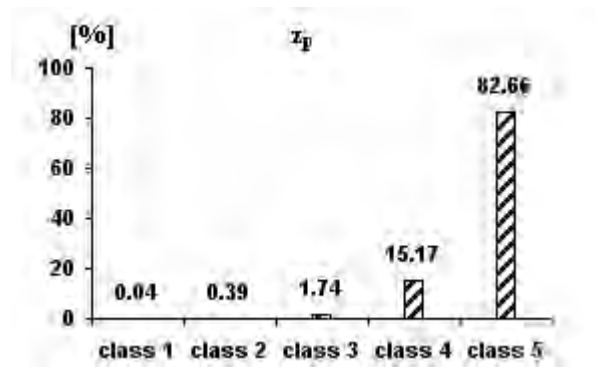
Figure 3 shows the percentage fraction of the sewers length with the movable sediment with the division into classes of failures. The sediment signed by the symbol z_p and show the percentage of the occupied sewer cross section fulfills successively the condition in classes 1 to 5: $z_p \geq 50$ (class 1), $35 \leq z_p < 50$ (class 2), $20 \leq z_p < 35$ (class 3), $5 \leq z_p < 20$ (class 4), $z_p < 5$ (class 5).

Fig. 3. The movable sediment z_p with the division into the classes of failures

The sediments in the bottom of the sewer, which come from the construction period, were connected in most cases with improper longitudinal gradient of the sewers. More than 80% of those sediments were assigned to 5th class of failures, because they occupied less than 5% of the sewer cross-section. To 4th class there was classified 15.17% of the sewer length which were occupied by the sediments, to 3rd class 1.74%, to 2nd class 0.39%, to 1st class only 0.04% of the sewer length which was occupied by the movable sediment occupying more than 50% of the sewer cross-section. Figure 10 shows the movable sediment, which was classified to 4th class of failures.

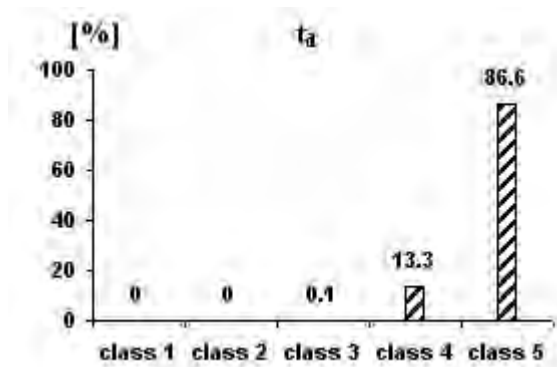
Figure 4 presents the per cent share of the sewer length with the observed deflections of the top with the division into the classes of failures. The deflection of the top is signed by the symbol t_d and expressed in per cent. It fulfills successively the condition in classes 1 to 5: $t_d \geq 40$, $25 \leq t_d < 40$, $15 \leq t_d < 25$, $6 \leq t_d < 15$, $t_d < 6$, where t_d is calculated from the equation:

Fig. 4. The deflection of the top t_d with the division into the classes of failures

The deflection of the pipe's top was observed on the considerable pipe's length. In 86.6% they were minor deflections, lower than 6%, qualified to 5th class of failures. To 4th class of failures there were classified 13.3% of the deflected pipes, where deflections were more than 6% and less than 15%. According to the proposed classification only 0.1% of the deflected pipes were classified to 3rd class. Their deflection was more than 15%. The deflection of the top of the pipe classified to the 4th class was shown in figure 12.

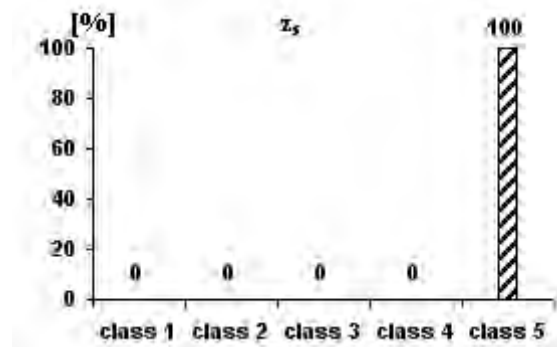
Figure 5 presents the per cent share of the sewer length with the immovable sediment with the division into classes of failures. The immovable sediment signed by the symbol z_s and expressed in the percentage of the occupied sewer cross-section fulfills successively the condition in classes 1 to 5: $z_s \geq 50$, $35 \leq z_s < 50$, $20 \leq z_s < 35$, $5 \leq z_s < 20$, $z_s < 5$.

Fig 5. The immovable sediment z_s with the division into the classes of failures

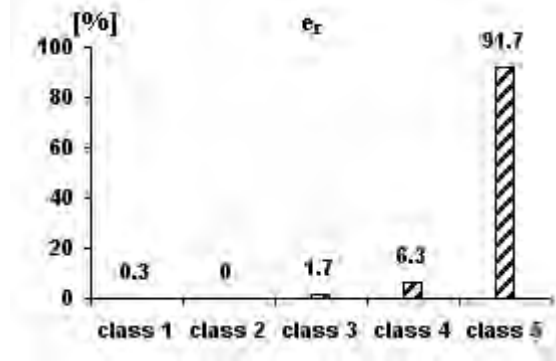
Fig. 6. The longitudinal displacements e_r with the division into the classes of failures

The point failures which were most commonly observed were: longitudinal displacements. The most of the longitudinal displacements (91.7%) was observed in the 5th class of failures. Only in one place (1st class – 0.3%) there was the direct contact of the interior of the pipe with the ground, shown in figure 13. Low one-sided longitudinal displacements (5th class) are shown in figure 14. It indicates the improper longitudinal slope.

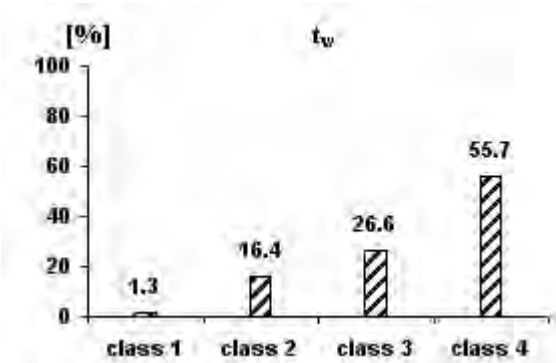
The local dents from e.g. sharp cobblers, signed by a symbol t_w were included in four groups of failures, in which the depth of dent is measured in [mm] and equal successively: $t_w \geq 20$ (class 1), $15 \leq t_w < 20$ (class 2), $10 \leq t_w < 15$ (class 3), $t_w < 10$ (class 4). Figure 7 presents assigning the observed local dents of PVC pipes to particular classes.

Fig. 7. The local dents t_w with the division into classes

More than half of the observed local dents e.g. from the cobbles were classified to the 4th class of failures. Less of the failures (26.6%) were classified to the 3rd class, much less (16.4%) were classified to the 2nd class. One dent of 1.3% was classified to 1 st class and was larger than 20 mm. The examples of the local dents are shown in figure 15.

The local dents observed in the investigated sewers indicate the careless carrying out the sand bedding and sand backfill of the pipes.

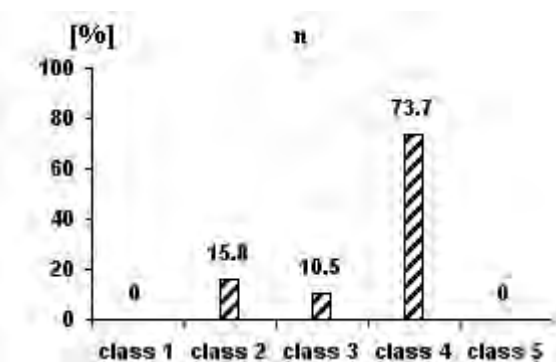
- Class 1 – intensive inflow or injection of groundwater, sometimes dribbling with the ground,
- Class 2 – minor inflow of groundwater without the ground,
- Class 3 – dribbling of groundwater without the ground,
- Class 4 – groundwater dripping in drops,
- Class 5 – moisture from the groundwater.

Fig. 8. Groundwater infiltration n into the Sewer interior with the division into the classes of failures

The groundwater infiltration to the pipe interior was observed only in one city. The water dripping was observed in 73.7%, which classified this failure to the 4th class, the dribbling of the water was observed in 10.5% (3rd class), the inflow of water into the pipe interior was observed in 15.8% (class 2).

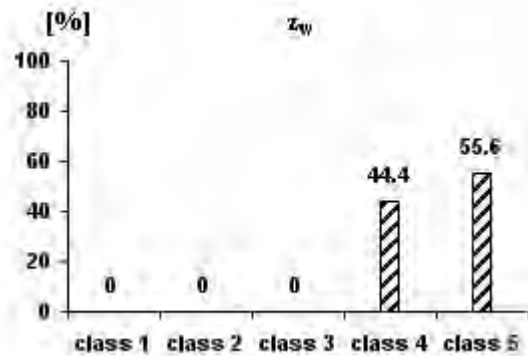
Figure 9 shows the per cent share of the observed house drains or sealing that jut out in the interior. This failure was signed by the symbol z_w and expressed in the per cent of the occupied sewer cross-section. It fulfills the following requirements, successively for classes from 1 to 5: $z_w \geq 50$ (class 1), $35 \leq z_w < 50$ (class 2), $20 \leq z_w < 35$ (class 3), $5 \leq z_w < 20$ (class 4), $z_w < 5$ (class V).

Fig. 9. House drains or sealing that jut out in the interior z_w with the division into the classes of failures

The house drains or the sealing that jut out to the interior in 55.6% occupied less than 5% of the pipe cross section and were classified to the 5th class of failures. 44% of those obstacles in the flow were classified to the 4th class, as they occupied more than 5% but less than 20% of the pipe interior. In figure 16 there is shown the house drain that juts out to the pipe's interior and unables the progress of the camera. In figure 17 there is shown the sealing which juts out of the connection.

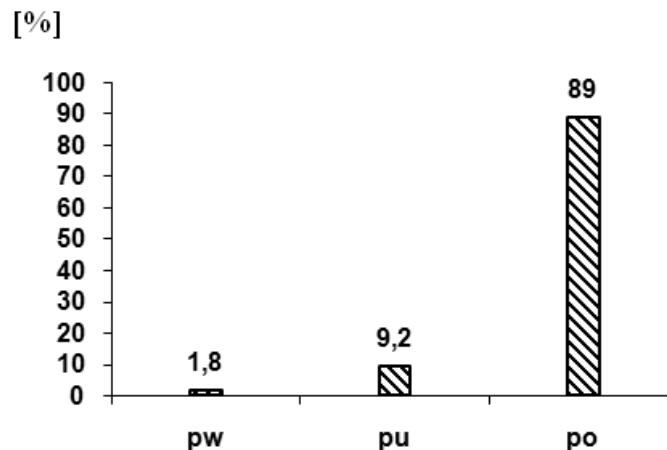
The minor percentage of the house drains was improper: 1.8% were jutting out to the interior, 9.2% were faulty, 89% were correct. The research results involving the connections are shown in figure 18.

Fig. 18. The correctness of the connections: p_w – the house drains that jut out to the pipe interior, p_u – the house drains that are faulty, p_o – they correct house drains

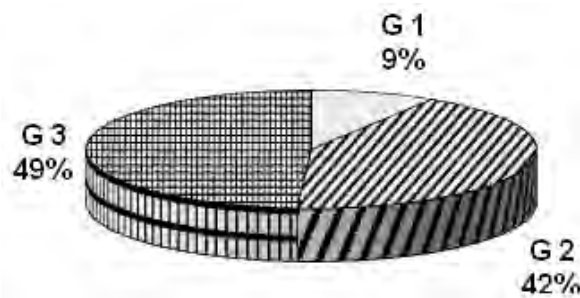
To the group G 1, that included the correct sewer sections (without any failures) there were classified only 9% of the Sewer sections. To the group G 2, that included one or several types of failures involved in the 5th class of failures there were classified 42% of the sewer sections. In case of long-exploited sewers pipes with such minor failures do not qualify to the rehabilitation. In case of the sewers newly laid in the ground it is a matter of discussion of those pipes should be taken to exploitation or not. In the standard concerning the requirements when sewer construction works acceptance should be adjusted the rules of sewer construction works acceptance for the sewers with the failures classified to the 5th class of failures. In the group G 3 there was a almost half of the sewer sections (49%), which had the larger failures, classified to classes from 1 to 4. Those sections are not qualified to the acceptance.

Fig. 19. The percentage of sewer sections from the groups: G 1 – without failures, G 2 – with failures in the 5th class, G 3 – with failures in classes 1 – 4
